Potable Water Line Rehabilitation with Compact Pipe

Through Fields and Meadows Without Trenches

Frequently recurring damage and the maintenance of high supply reliability were the convincing arguments for the rehabilitation of a drinking water line in Tönisvorst. The Compact Pipe Method was employed – with compelling results.

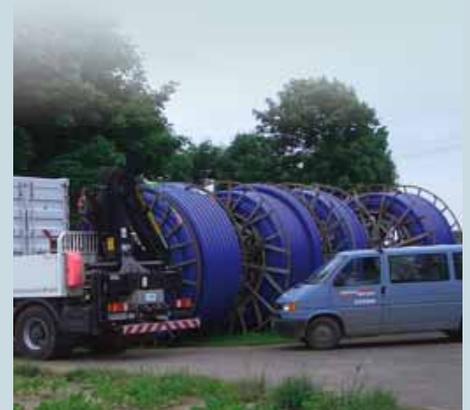
The Compact Pipe is pulled into the damaged line.

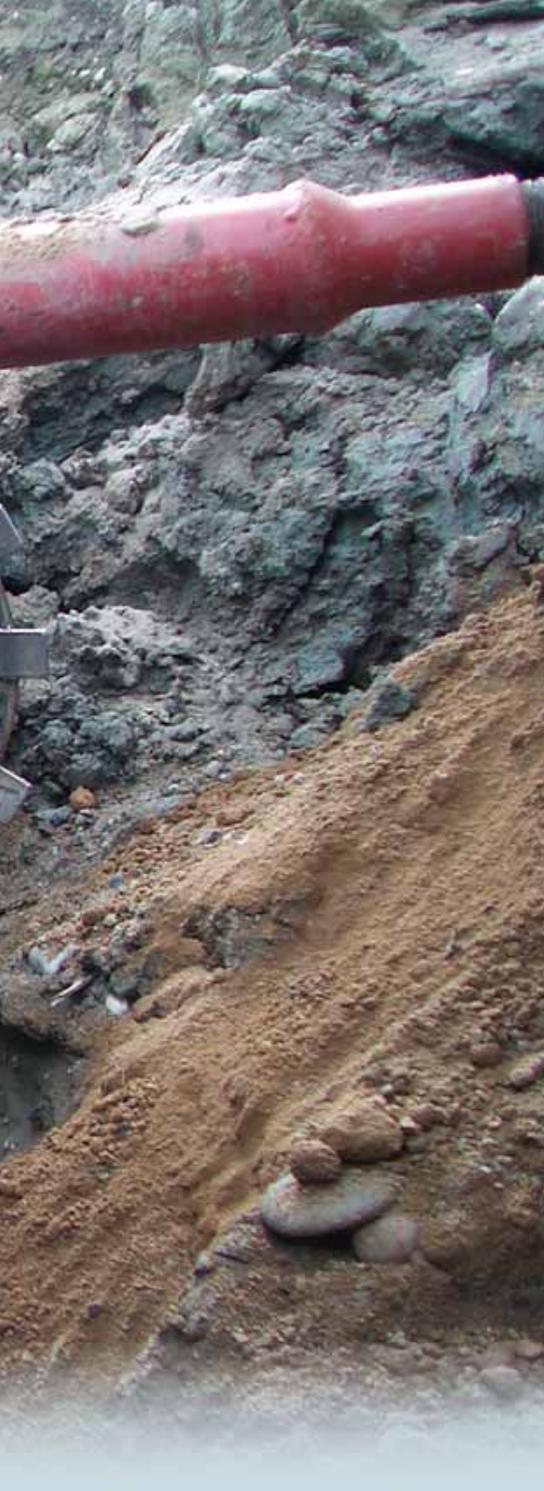
Up to 410 m of Compact Pipe OD 250 was wound onto a drum.

These marginal conditions were ideal for the Compact Pipe method. Pulling lengths between 200 and 410 metres were feasible. The only limiting factor for the length of the single sections was the maximal pipe length to be wound on a reel. There was another reason to opt for the trenchless method: since it was a transmission pipeline, lateral integration was not called for.

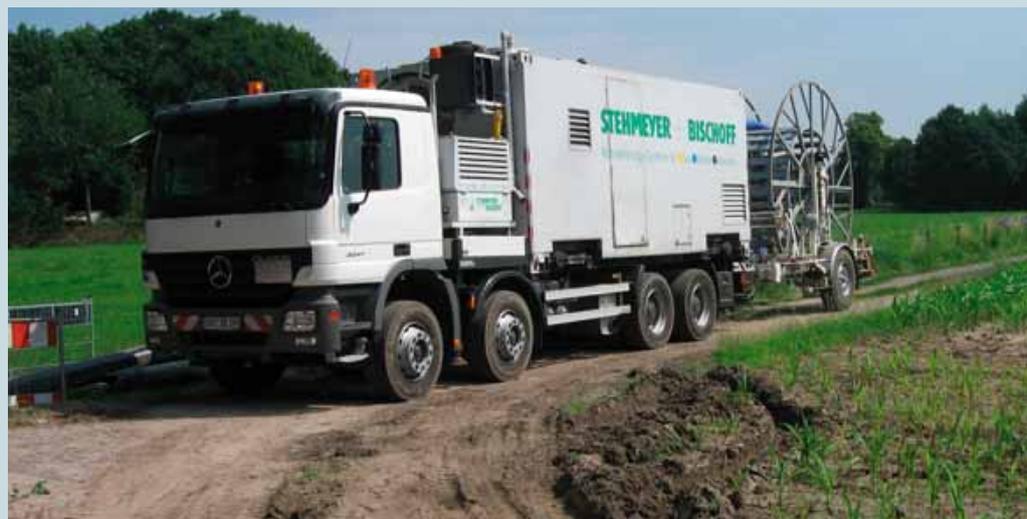
Actually the classical marginal conditions for an excavator and open construction: the path of the line mainly runs along access roads or through agricultural land.

New installation or rehabilitation of the existing lines – these were the alternatives considered in the attempt to solve the problem. The path of the line mainly runs along access roads or through agricultural land.

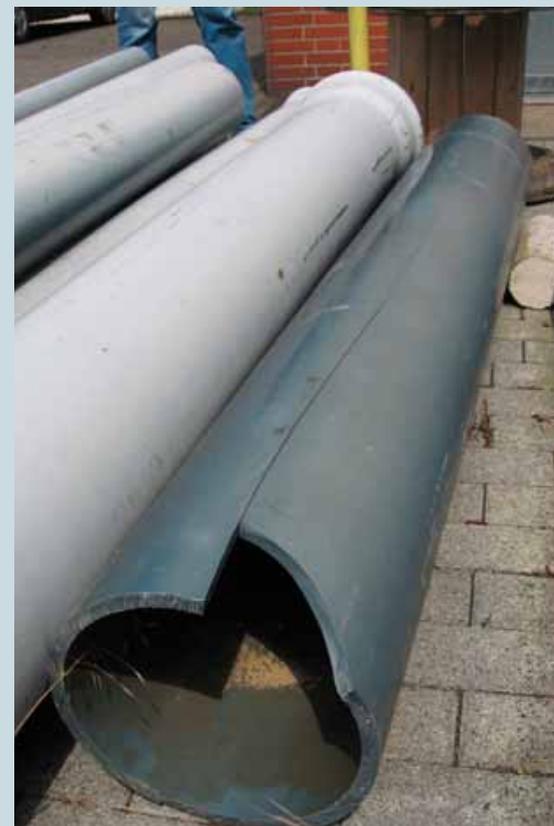
Typical damage aspects of PVC pipes manufactured in the early 1970ies: crack formation at the ridge.

The damage found when investigating was a crack formation of the ridge. This weak point,

causally determined by the production technique at that time, was a problem that all manufacturers of PVC pipes had to face in the early 1970ies, Heinrich Bollmer from the application technology department of the pipe producer Wavin explains to us.

Expressed in simplified terms, the pipe was longitudinally cut open during production and then joined together again under the influence of heat and pressure. The seams of the PVC pipes, generated in production, present an increased hazard. If such a pipe is subject to pressure, particularly impact pressure, it tends to splitting open completely. This failure was recognised very quickly and rectified immediately, Heinrich Bollmer emphasises. Still there are a few places left where this damage aspect is unearthed, as the line in Tönisvorst shows.

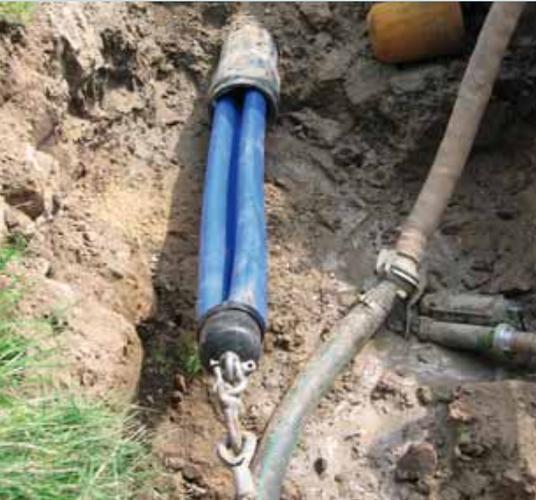
Compact Pipe with the pulling head welded on.

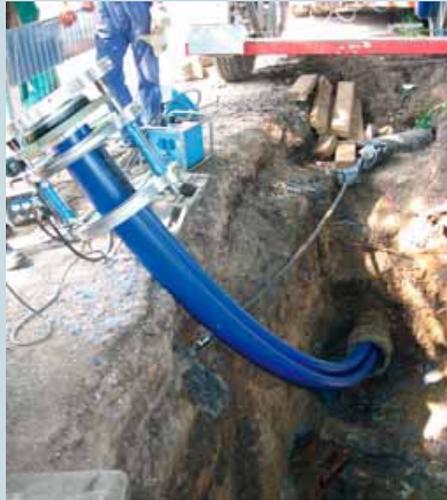
Preparing the heat-up phase.

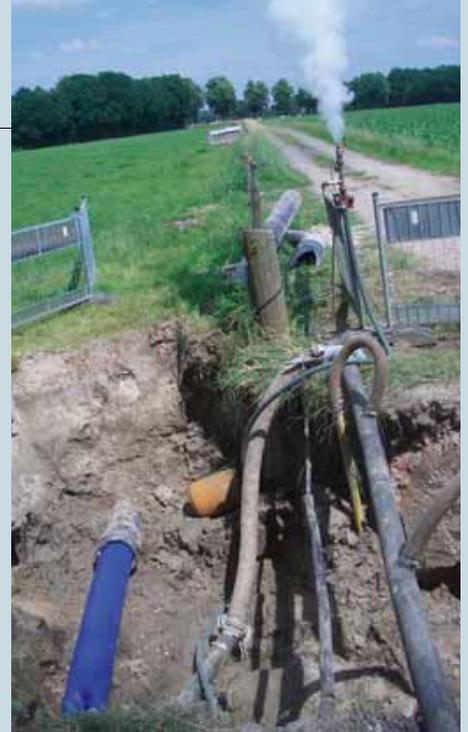
Getting the steam up: the installed pipe is being heated up.

When the Compact Pipe is made, a round pipe is produced, cooled down and formed like a C at a precisely defined temperature. For production-technical reasons, this processing temperature is an industrial secret. This specific temperature is responsible for the so-called "memory effect". It makes sure that the pipe, reduced in its cross-section by the deformation process, "remembers" its original shape after having been pulled in and heated up with hot steam. After this step, the pipe is rounded again and nestles snugly up against the inner wall of the old pipe in a close fit without needing additional inner pressure.

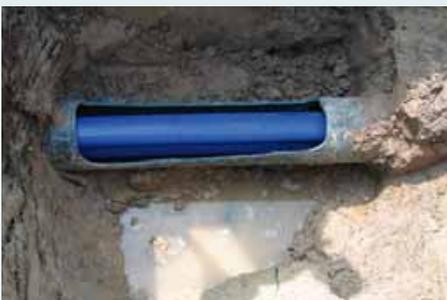
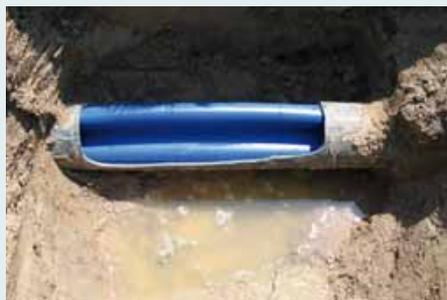
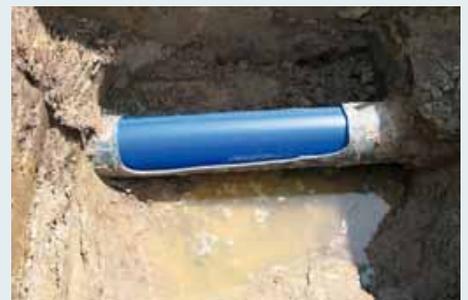
The intermediate pit, involuntarily established to repair a defect of the pulling-in tooling, was the ideal window for watching the reforming process of the Compact Pipe.

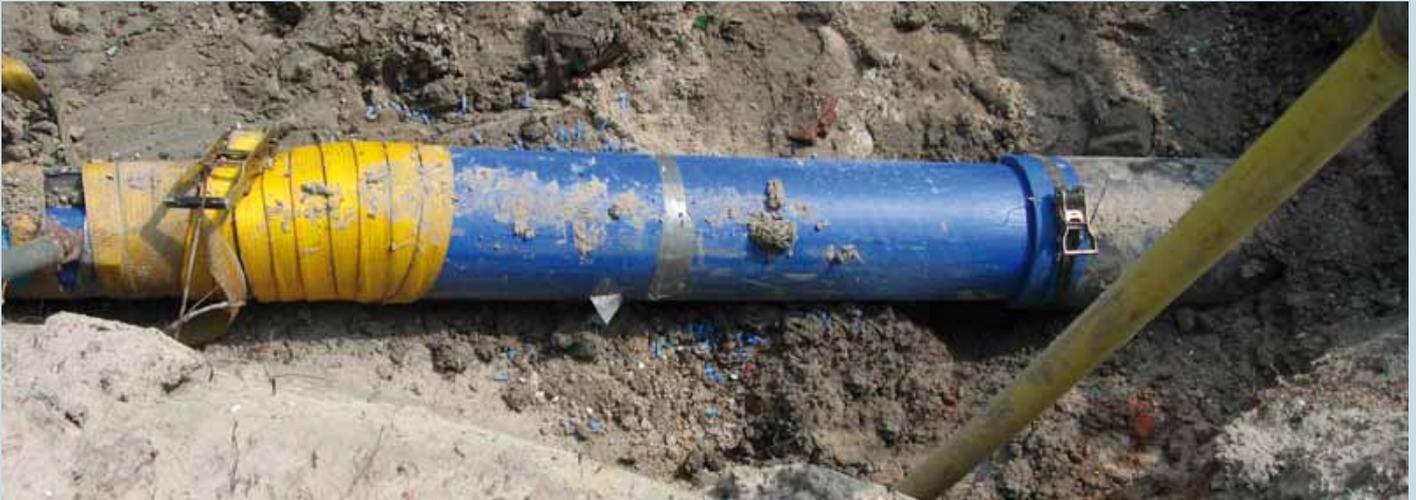
Unimpressive, but particularly important: the welded-on fixed point prevents the pipe from getting shorter when it is heated up.

The specific properties of PE do demand a certain amount of know-how from the company installing the Compact Pipe. During production of the PE pipe, it is pulled out of the extruder and, conditional of manufacturing, traction forces additionally affect the pipe during the forming process. This causes axial tension in the Compact Pipe which wants to be relieved during the heating operation on site. Shortening of the pipe to the point of three percent can be the result. This is prevented with so-called fixed points made of PE, which are welded on to the pipe ends. They brace the new pipe in

the old, thus avoiding a shortening of the new pipe. "The axial tensions are relieved by 80 percent in the next three months, remaining tension can still be found after 10 further years", Heinrich Bollmer explains and stresses the particular importance of this phenomenon for the renewal of sewers with laterals. "If this is not regarded, there is a certain risk of the integrated laterals tearing off subsequently. The fixed points rule out this hazard and the laterals can be safely connected to the AKE system."
